**Draft Report  
Project No. 60251**

**Volume 1 of 5  
Remedial Investigation Report  
ACS NPL Site  
Griffith, Indiana**

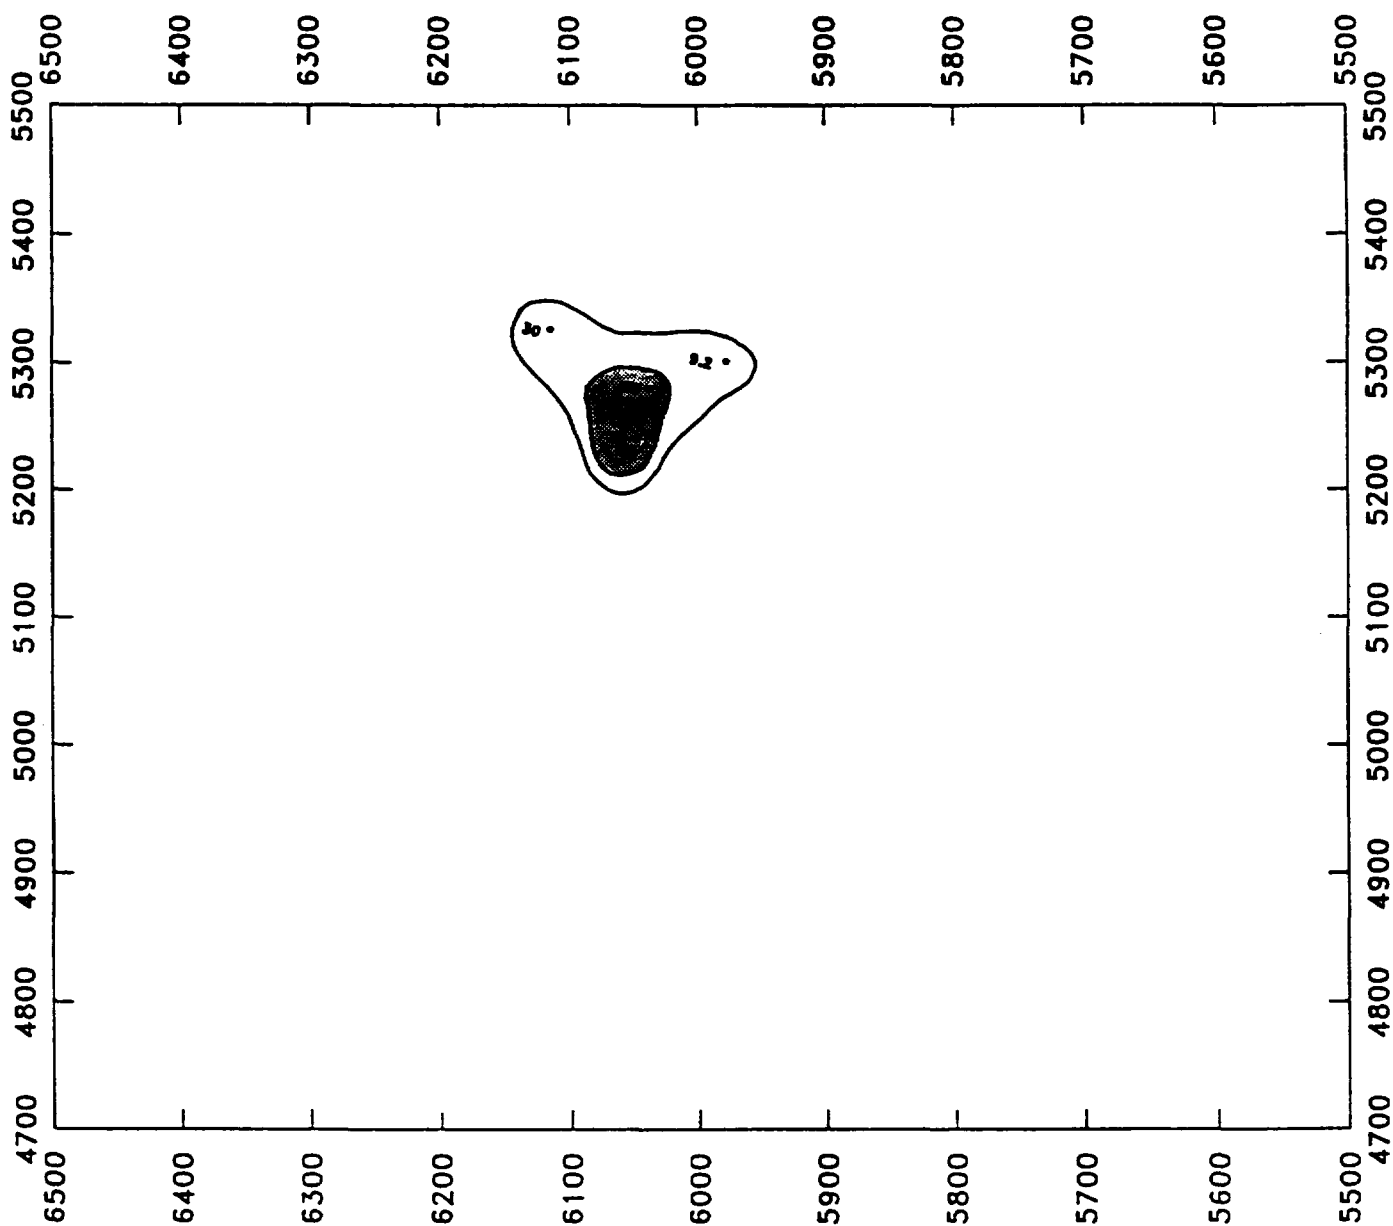
Figure 5-10e    Approximate Extent of Total PCB Containing Wastes (> 1 ppm, shaded >50 ppm), Off-Site Areas (12-17 feet below surface)

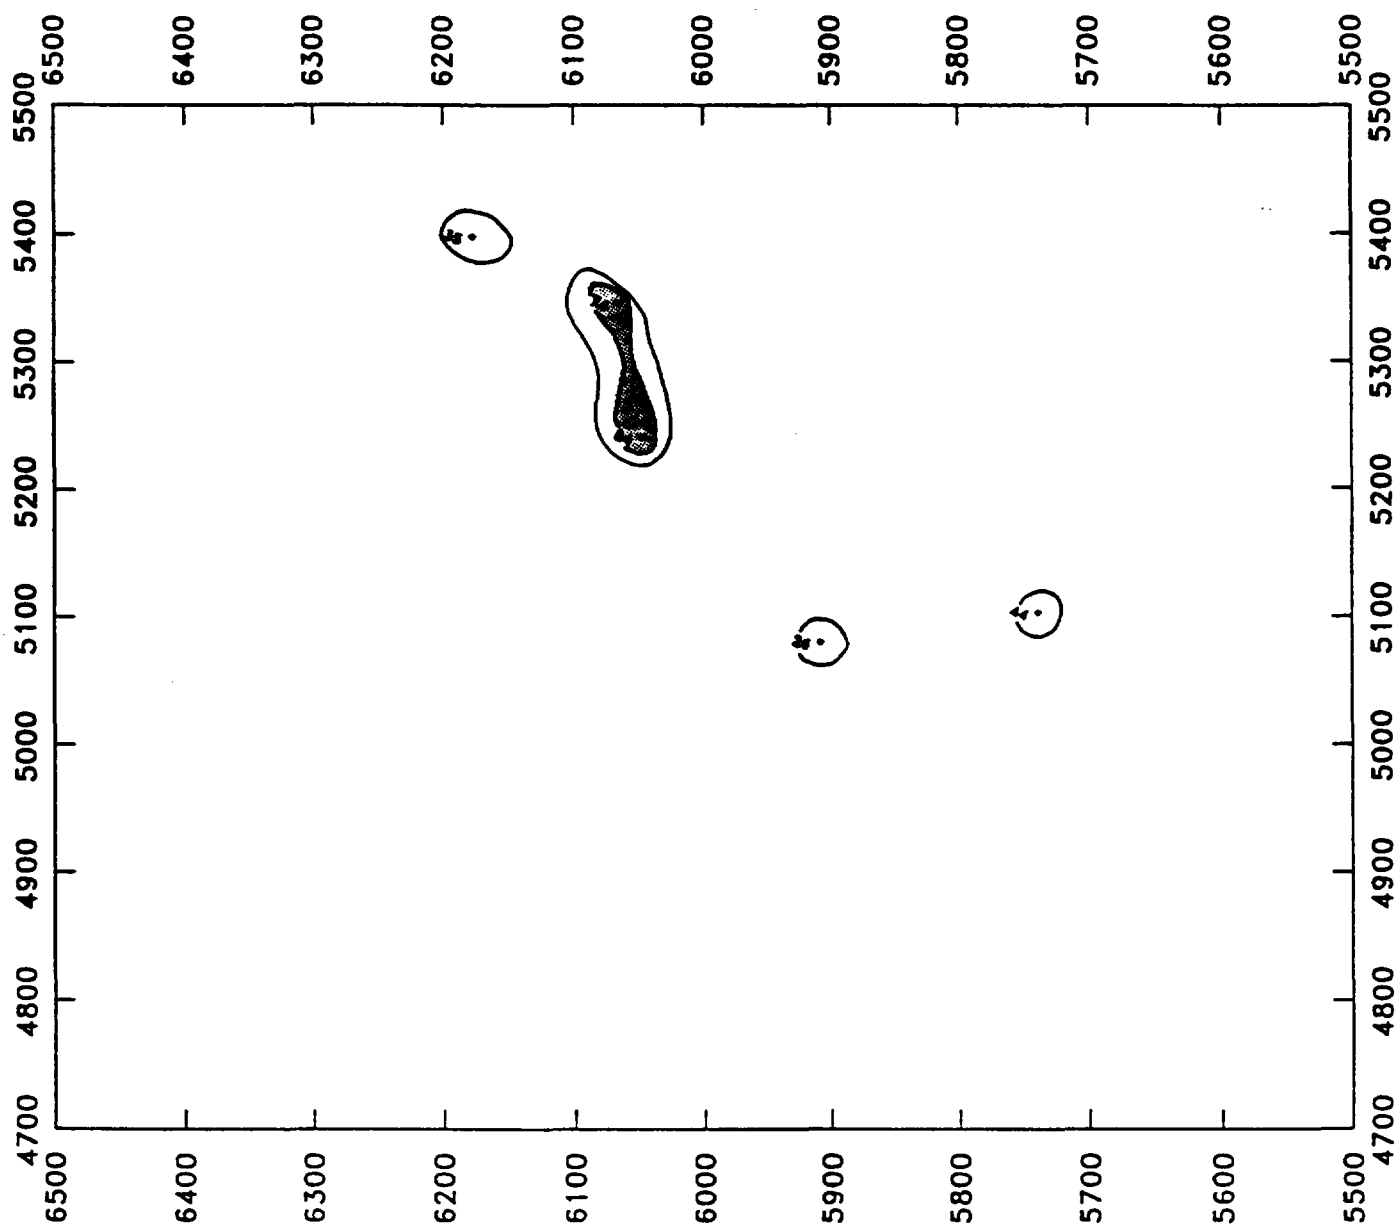
Figure 5-10d Approximate Extent of Total PCB Containing Wastes ( $> 1$  ppm, shaded  $> 50$  ppm), Off-Site Areas (8-12 feet below surface)

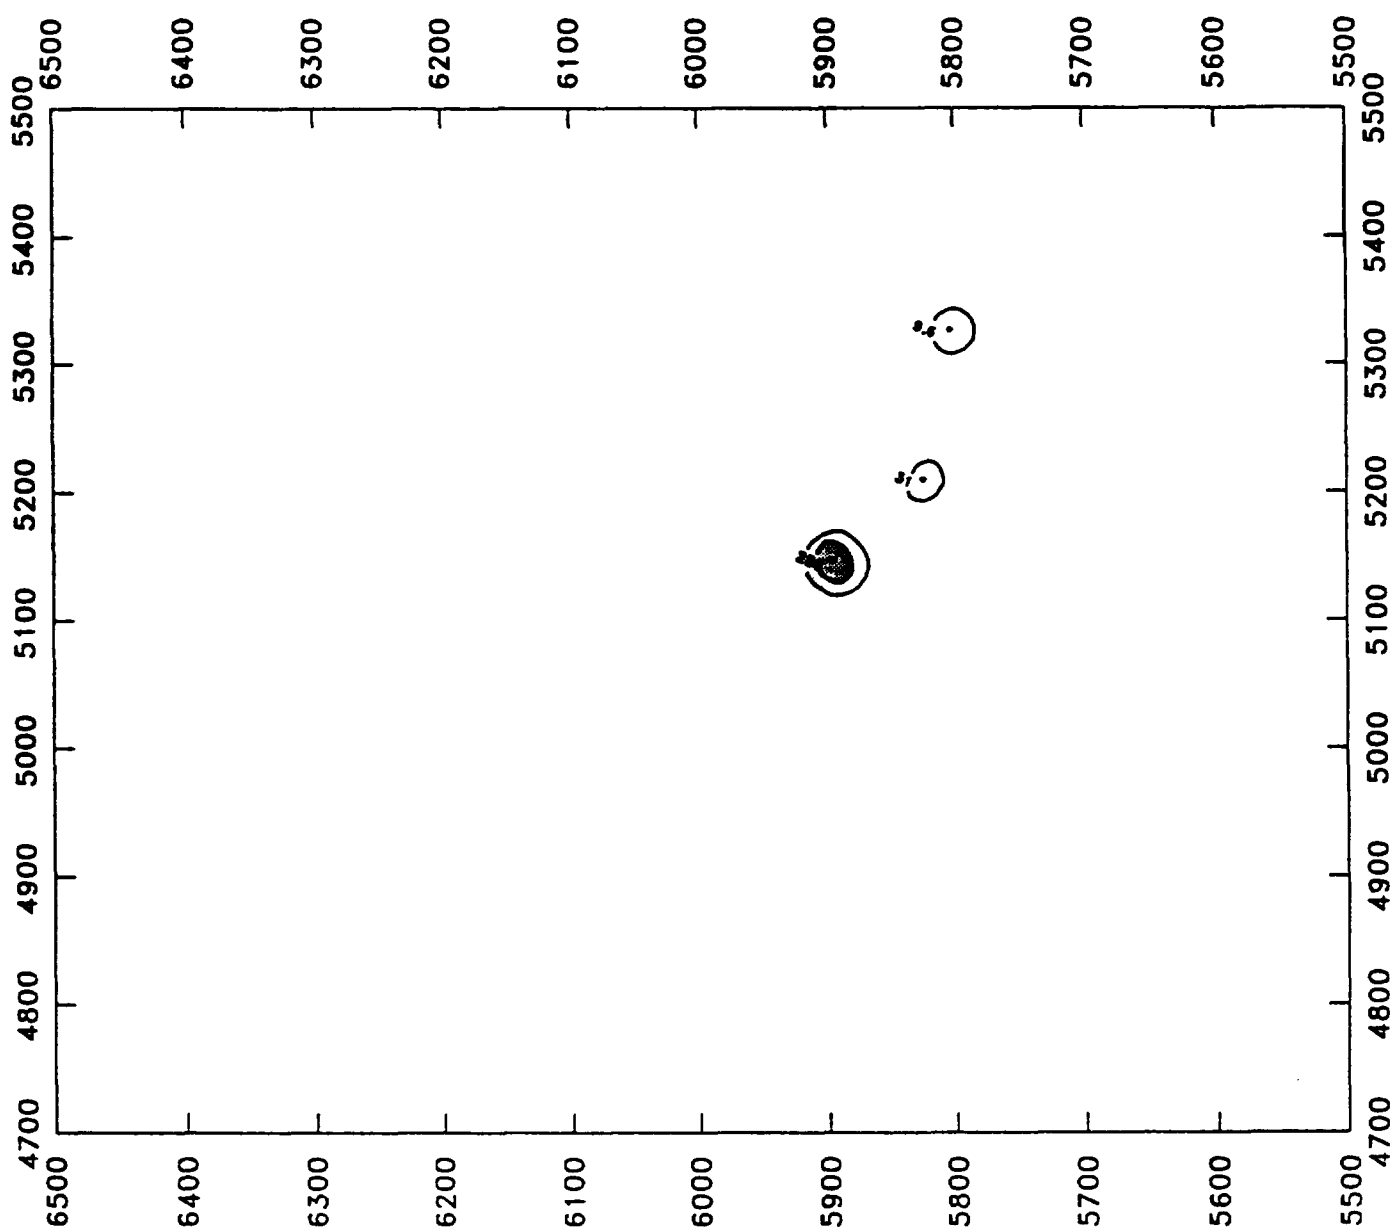
Figure 5-10c    Approximate Extent of Total PCB Containing Wastes (> 1 ppm, shaded > 50 ppm), Off-Site Areas (6-8 feet below surface)

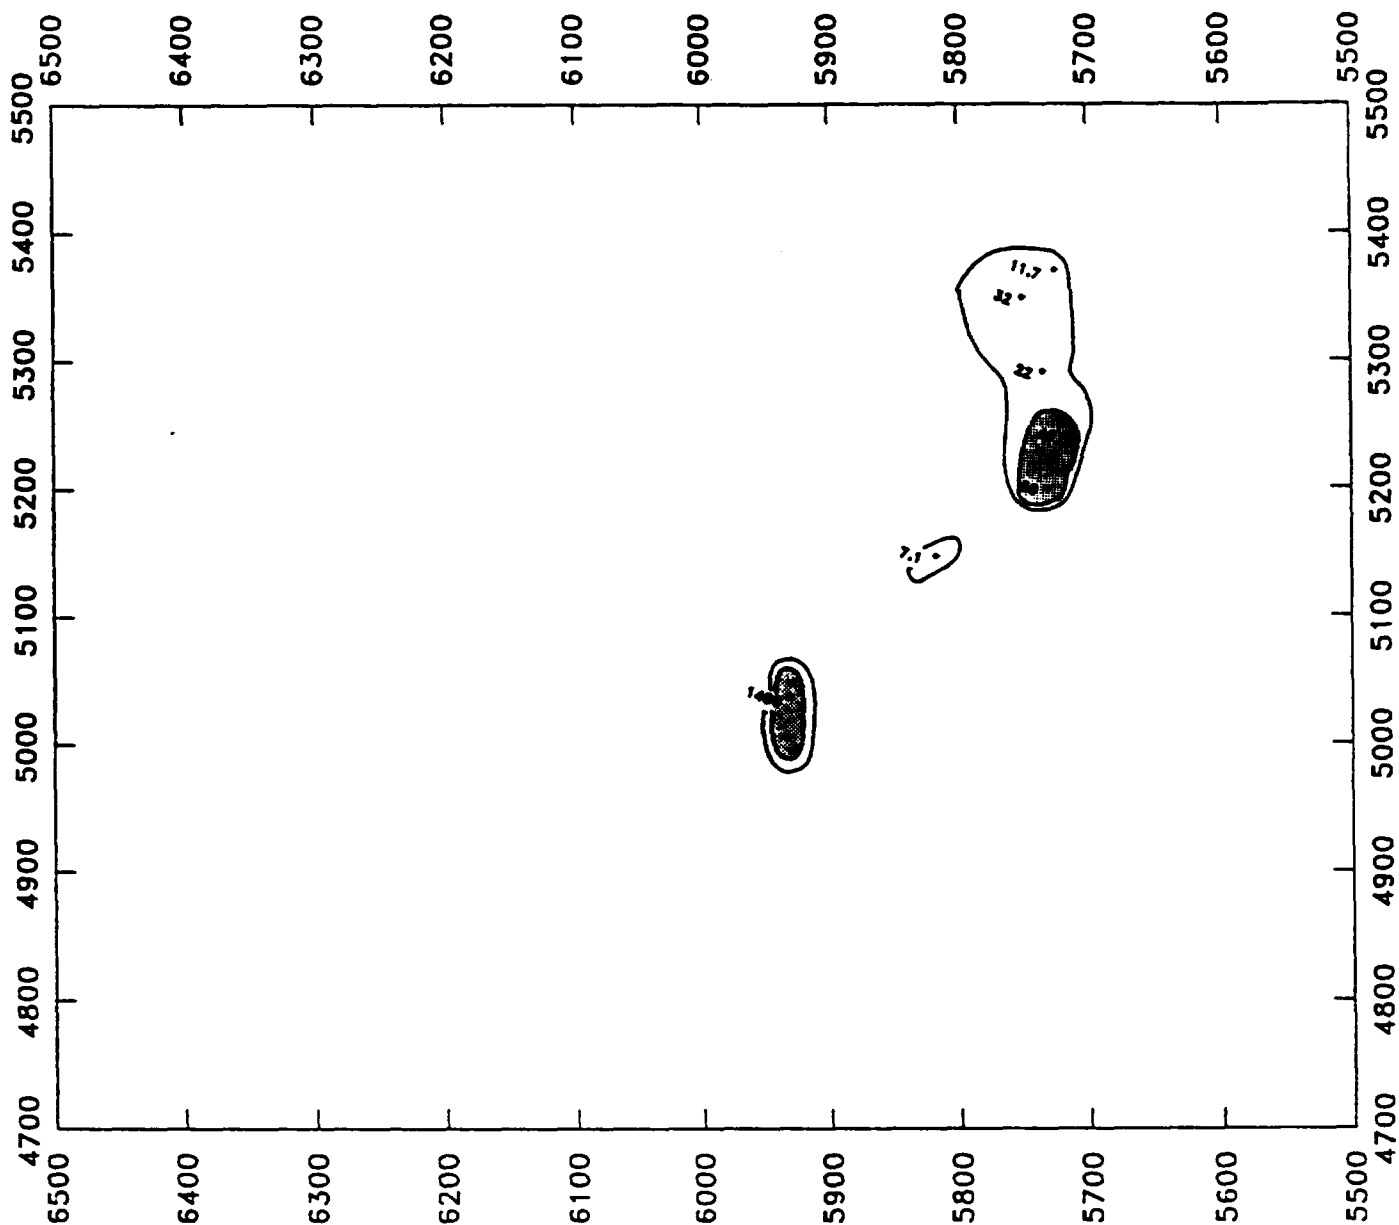
Figure S-10a Approximate Extent of Total PCB Containing Wastes (> 1 ppm, shaded > 50 ppm), Off-Site Areas (0-3 feet below surface)

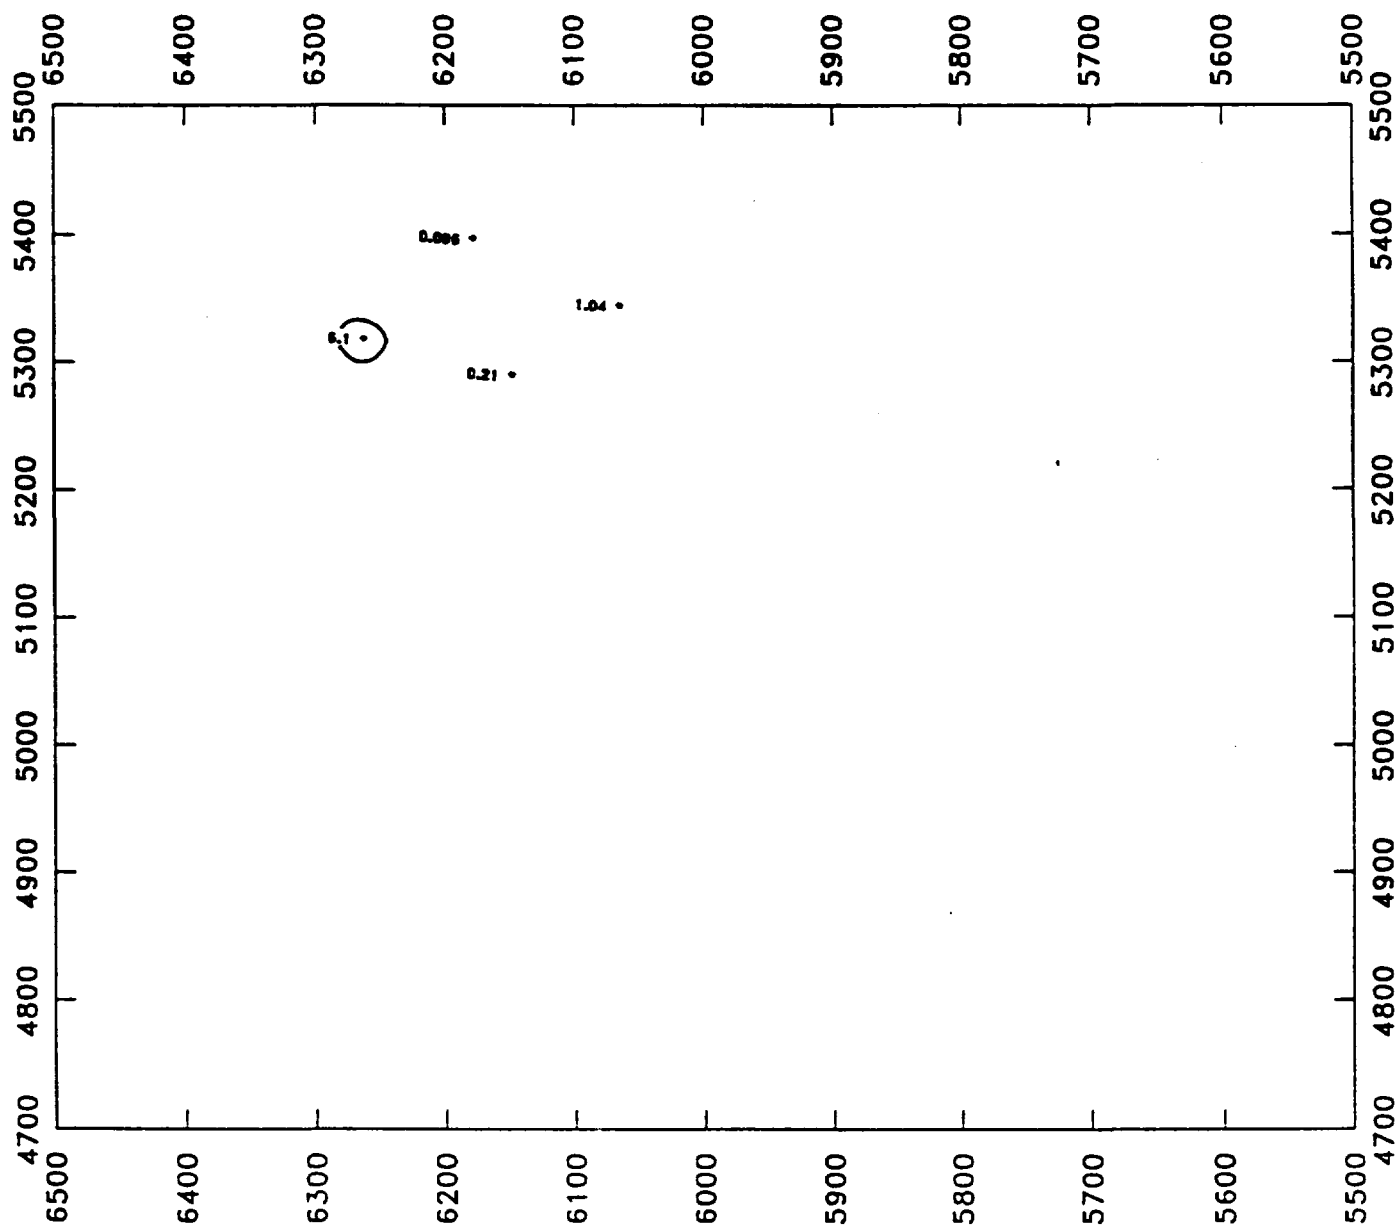
Figure 5-10g Approximate Extent of Total PCB Containing Wastes (> 1 ppm, shaded > 50 ppm), Off-Site Areas (24-26 feet below surface)
